**Addendum No. 2**  
Maple Street Shelter

**MAPLE STREET SHELTER**  
**1580 Maple Street**  
**Redwood City, CA**  
**Project No. PC019**

July 19, 2016  
BAGG Job No. COUSM-16-04

**Pre-Renovation Hazardous Materials Survey  
LifeMoves Shelter  
1580 Maple Street, Redwood City, California**

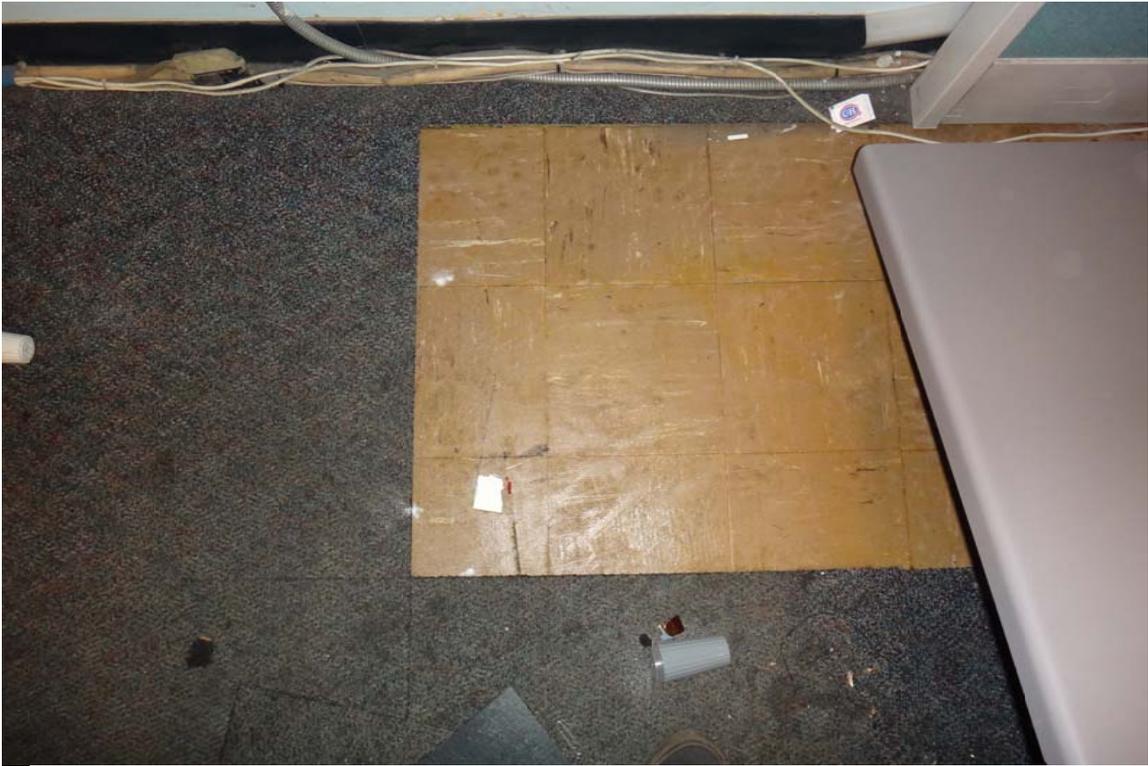
9"x9" Vinyl Floor Tile/Mastic

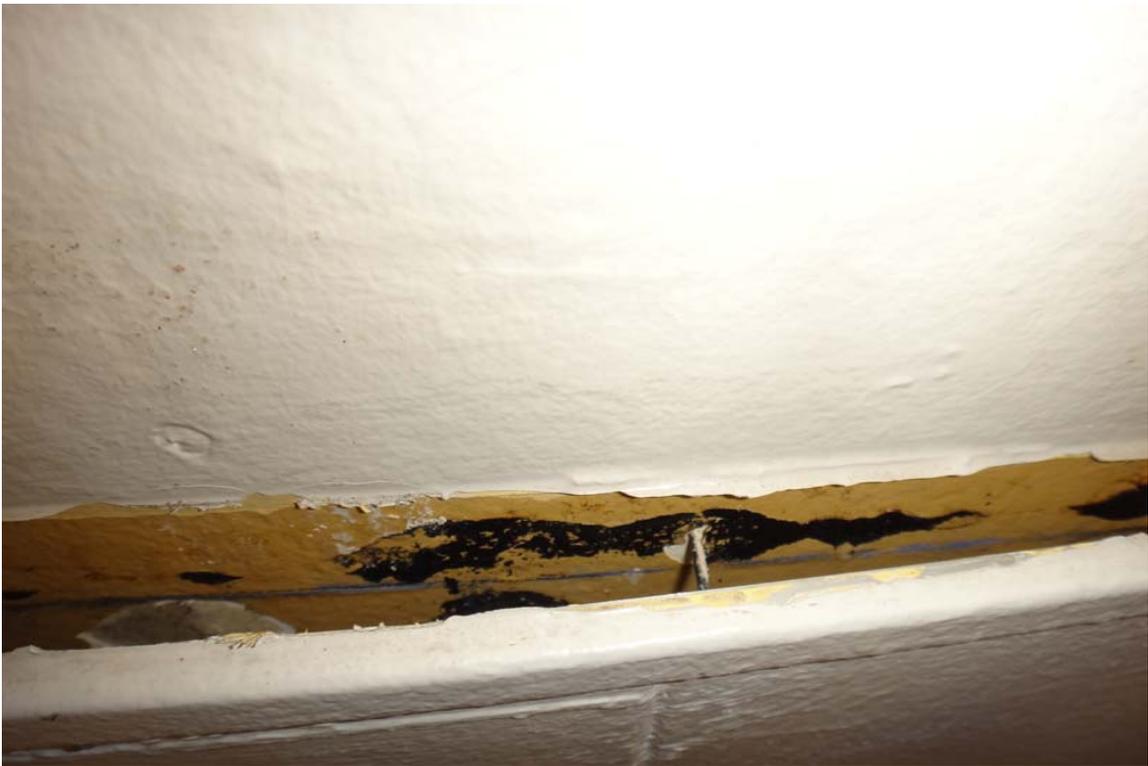
Wall Panel Mastic

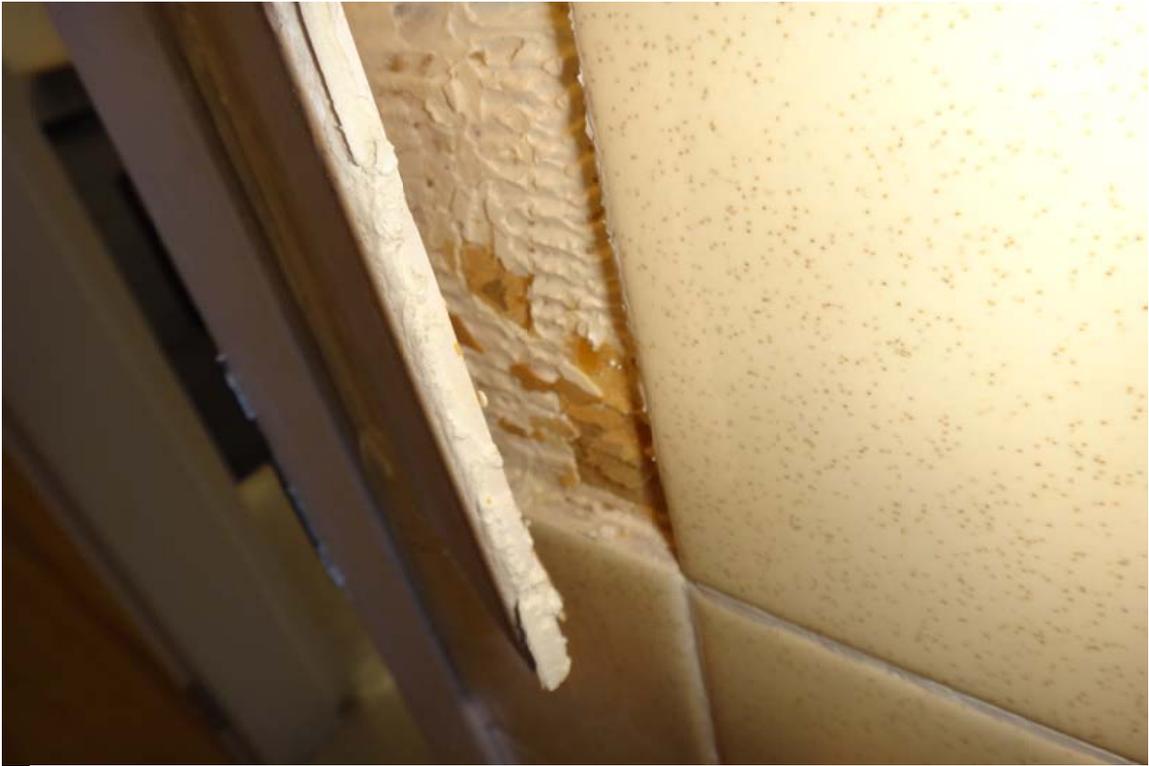
Mastic/Grout

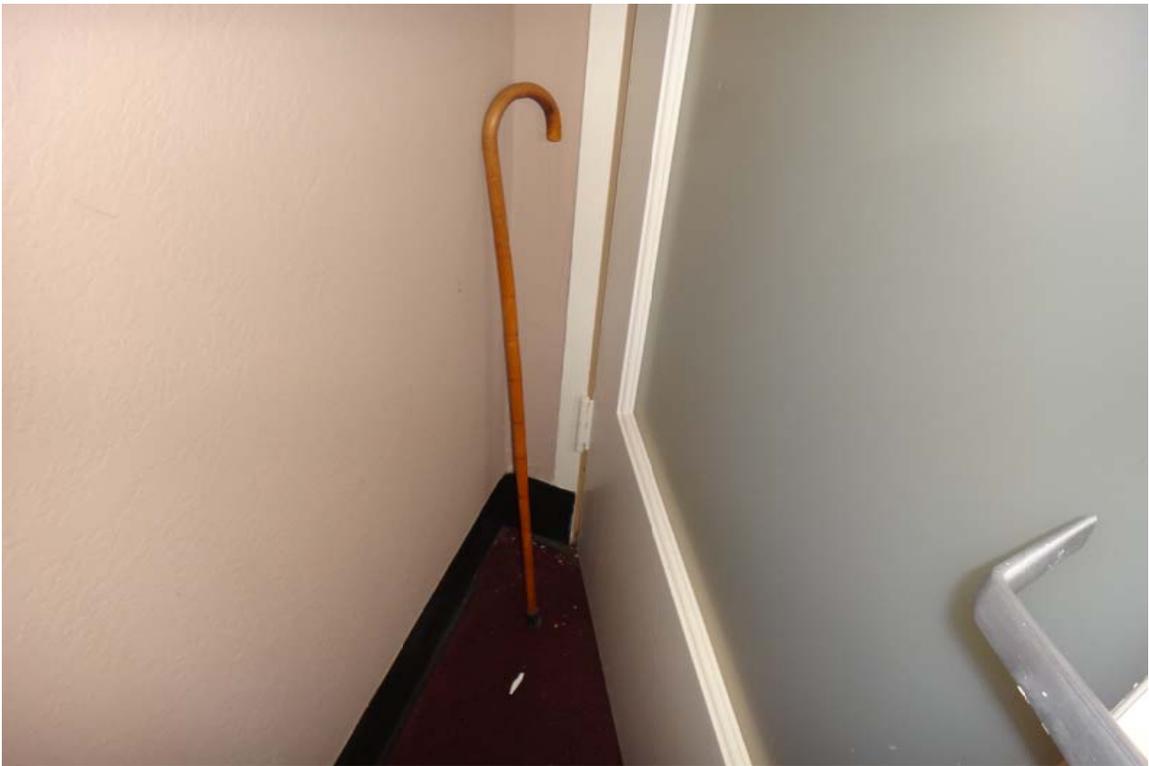
Texture Coat

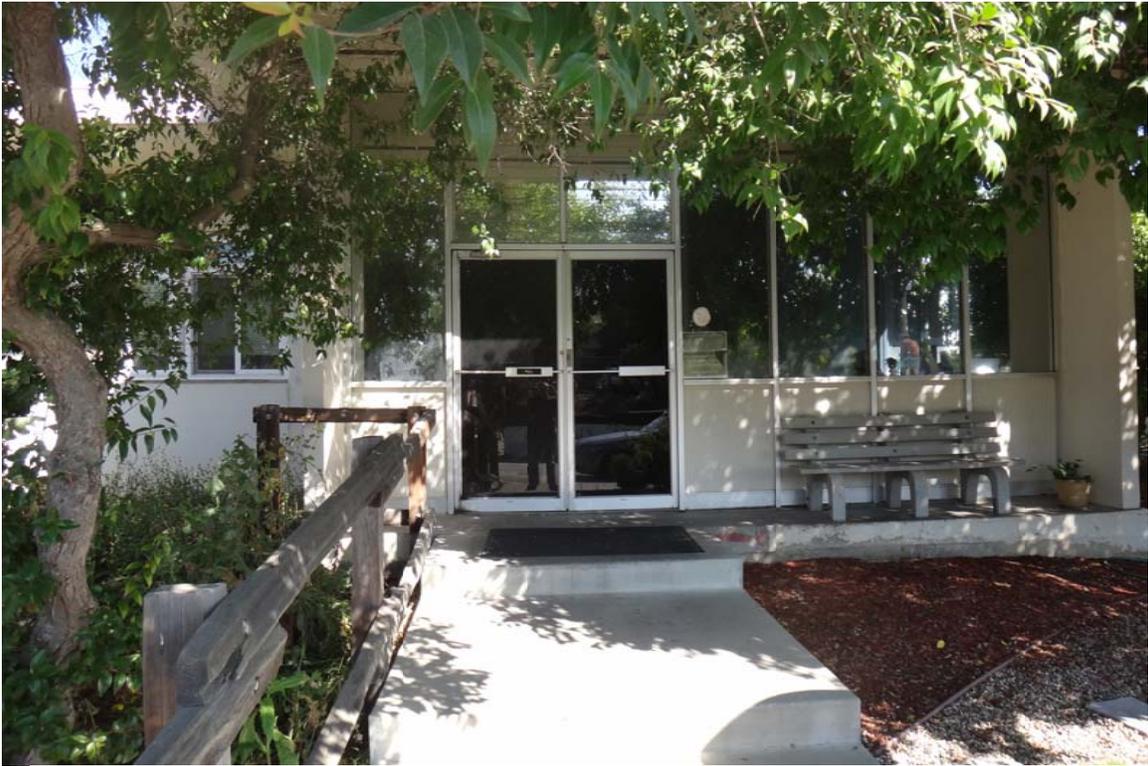
Window Panel

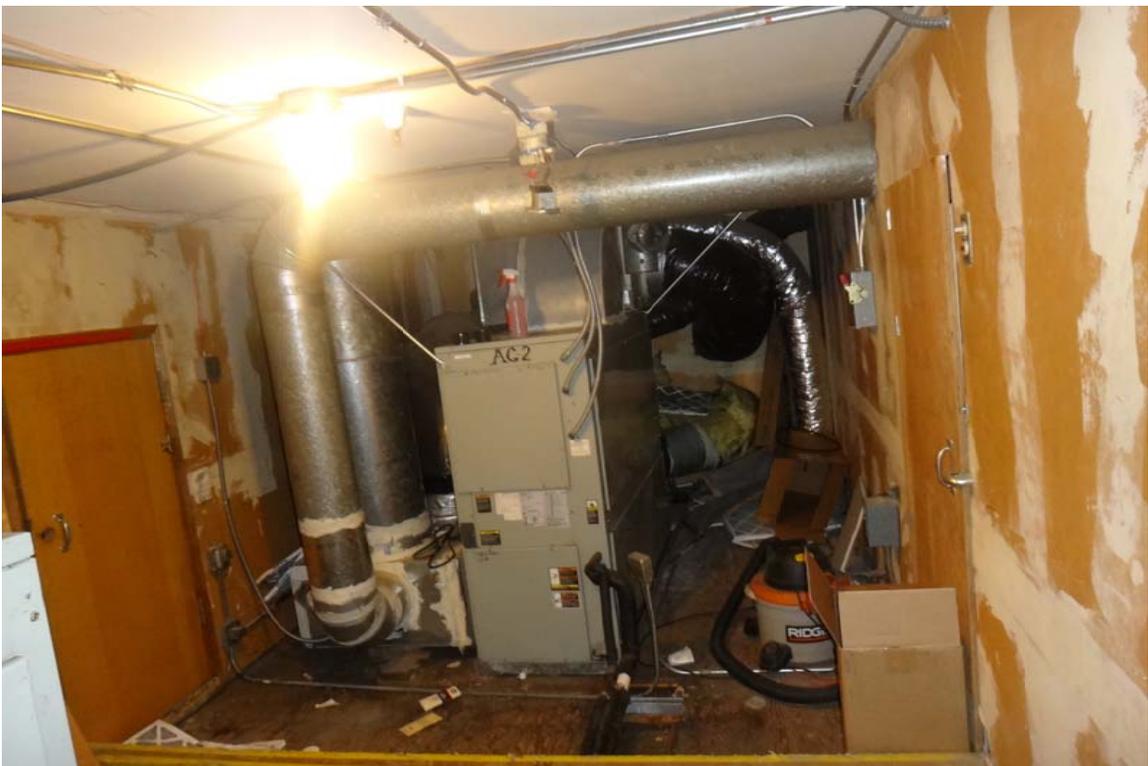
Wallboard/Joint Compound
