**GEOLOGIC AND GEOTECHNICAL INVESTIGATION
SCENIC DRIVE LANDSLIDE**

SAN MATEO COUNTY, CALIFORNIA

**JUNE 13, 2018
PROJECT PA17.1039.00**

**County of San Mateo
Department of Public Works
555 County Center, 5th Floor
Redwood City, CA 94063-1665**

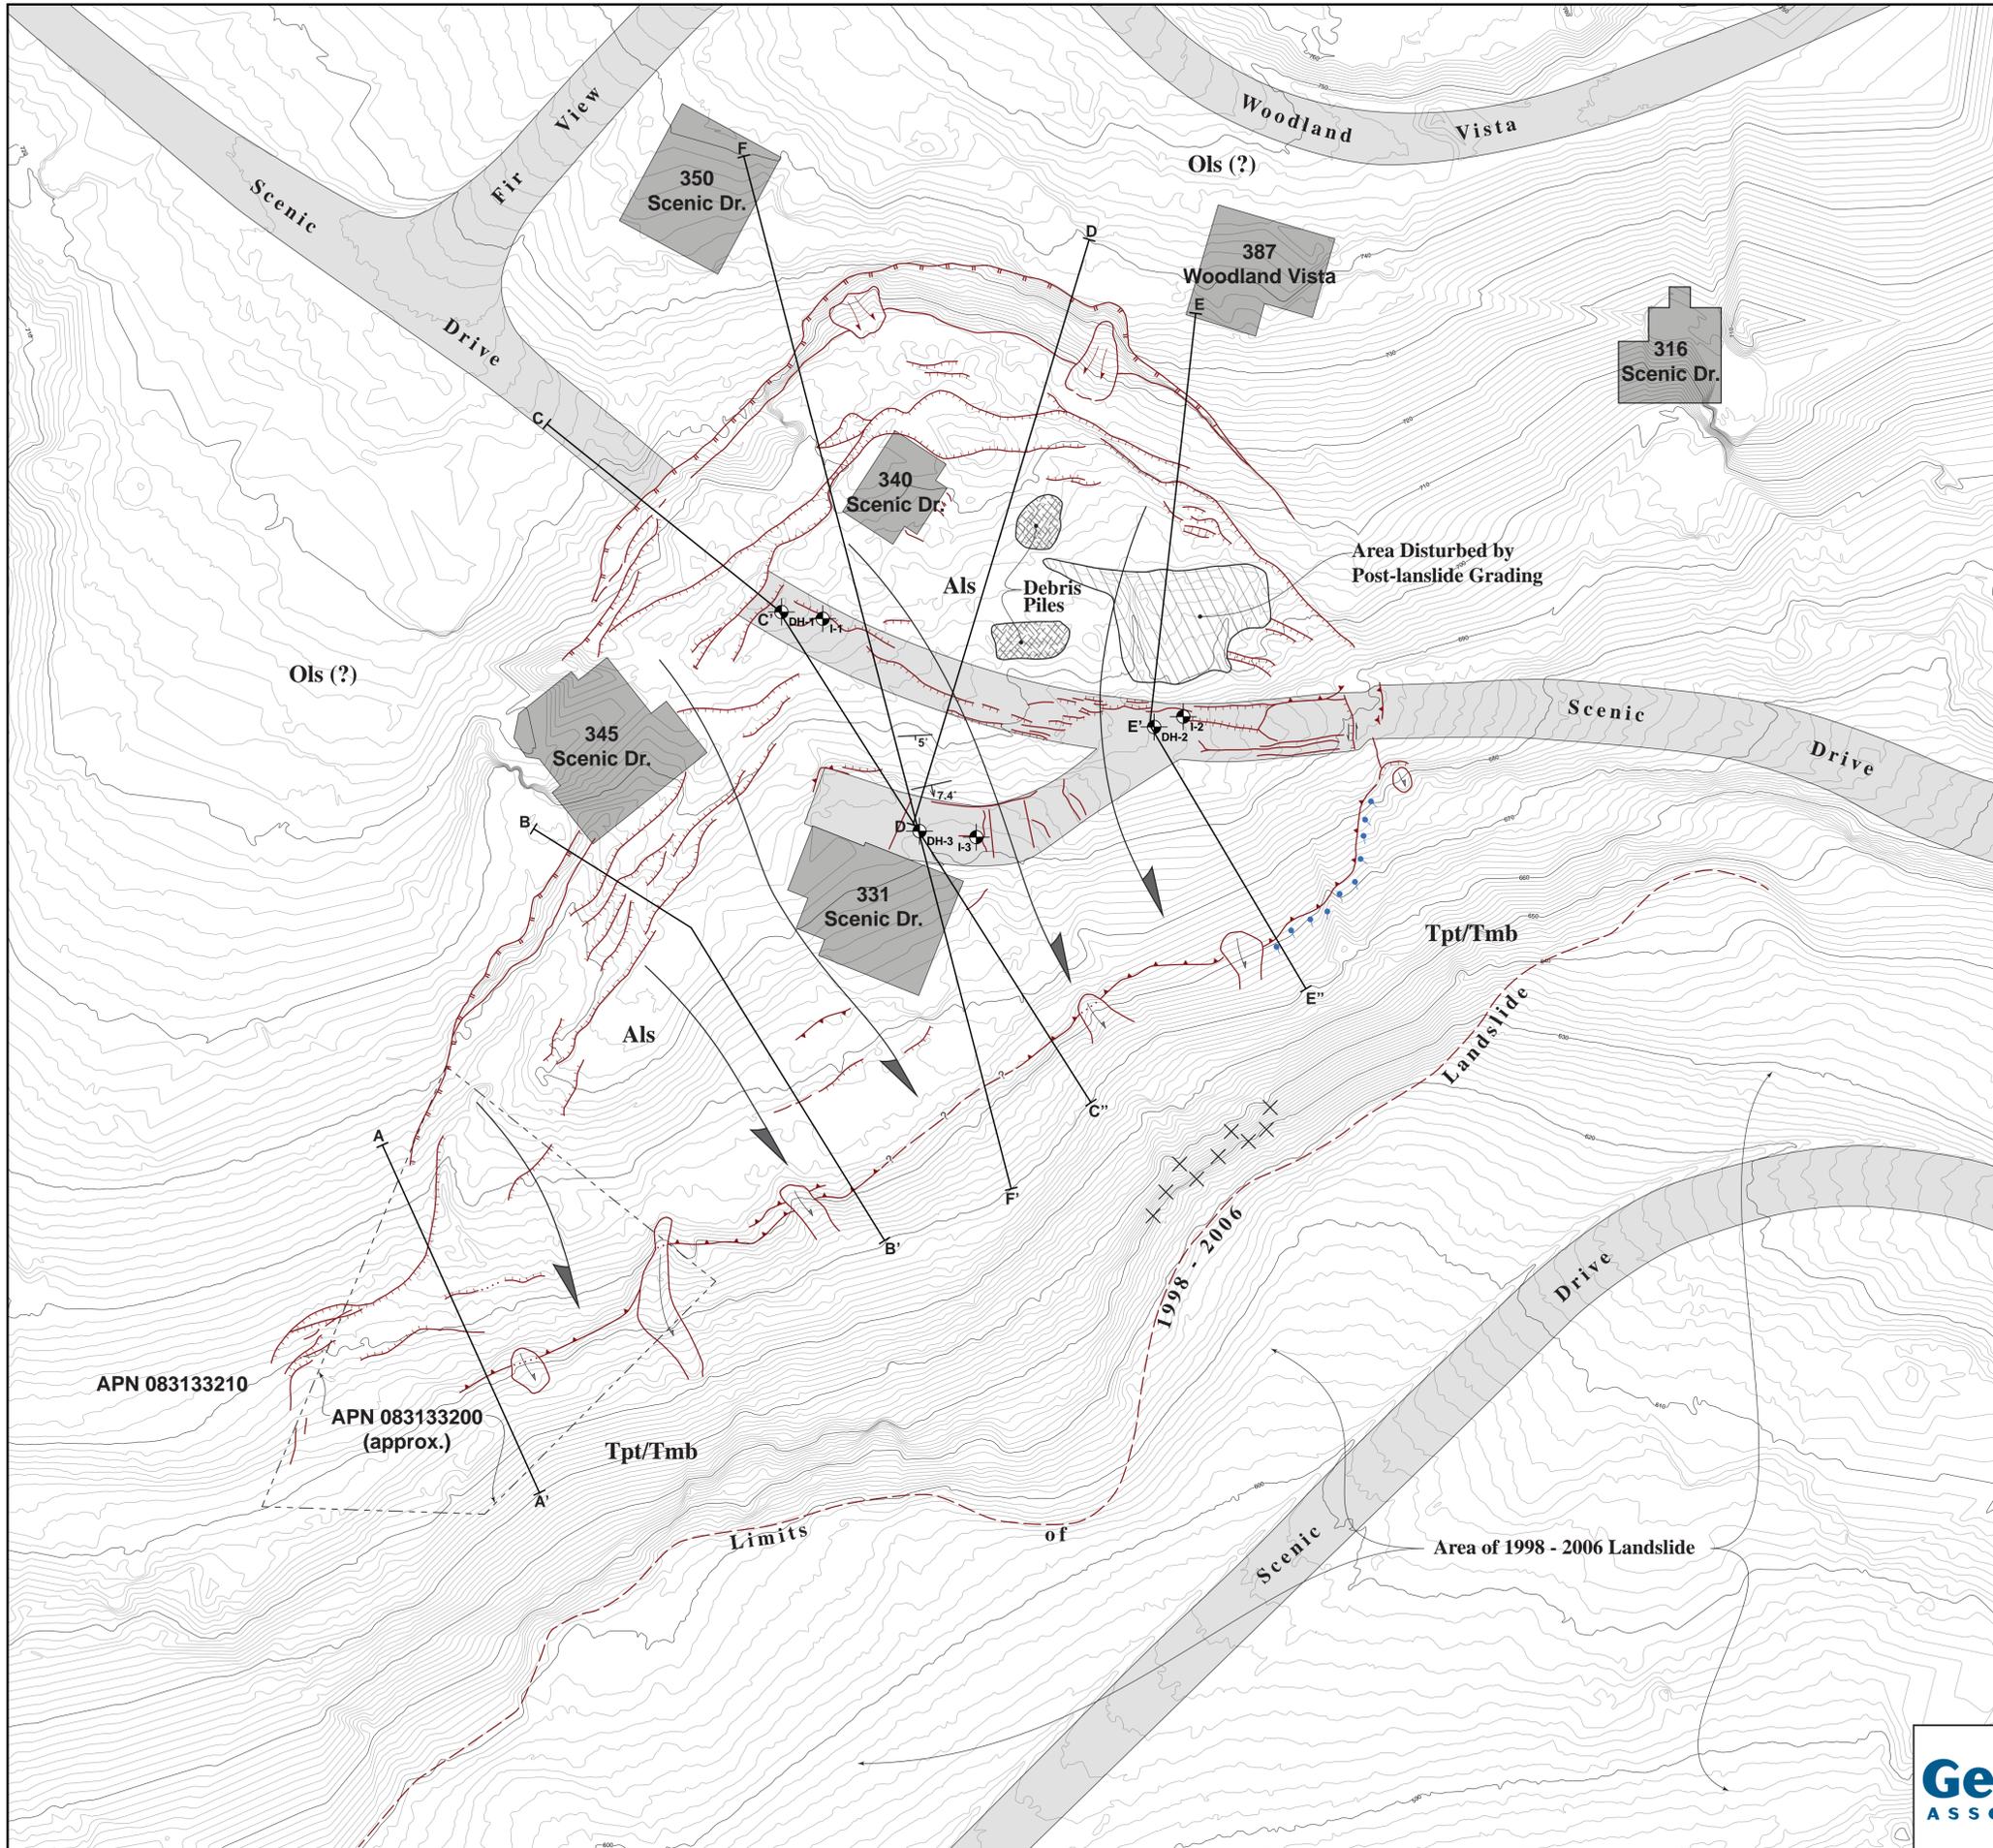
SITE GEOLOGIC MAP
SCENIC DRIVE
SAN MATEO COUNTY, CALIFORNIA

As shown by the topographic contours on the Site Geologic Map (Figure 4), the current landslide is situated on a gently inclined bench above steep slopes separating upper and lower sections of Scenic Drive. The lower section of Scenic Drive shown on Figure 4 traverses a repaired section of the 1998-2006 Scenic Drive Landslide from northwest to southeast and the relatively steep slopes shown in Figure 4 form the scarp of the 1998-2006 landslide. The current landslide cuts Scenic Drive at two locations (north and south). On the north side of the landslide, the roadway is cut by paired scarps with a total relief of approximately 10 feet. A well-defined arcuate scarp is present along the east side of the landslide, where the maximum height of the scarp reaches approximately 18 feet. Vertical relief across the scarp decreases progressively to the southwest approaching the southern break in Scenic Drive. The scarp transitions to partitioned thrusts and translational faults where it cuts Scenic Drive at the southern limit of the landslide.

From the northern break in Scenic Drive, the scarp extends northwestward, stepping slightly to the southwest beneath the residence at 345 Scenic Drive. From there, the scarp continues to the northwest and culminates in a series of stepping, en-echelon tears approximately 360 feet northwest of the northern break in Scenic Drive. The linkage of these tears to the toe of the slide is not expressed at the ground surface in this area. Sizeable tension cracks that locally define uphill-facing internal scarps and grabens are present throughout the upper approximately one-quarter of the landslide mass. These scarps and grabens appear to reflect the down-drop of material into voids left behind by block movement away from the head scarp. The toe of the landslide extends northwestward along topographic contour for approximately 405 feet from about 15 feet west of the southern break in Scenic Drive. The toe of the landslide is expressed as an emergent thrust with associated ground cracking of the landslide mass. Back thrusts are locally present within the leading edge of the landslide mass above the toe.

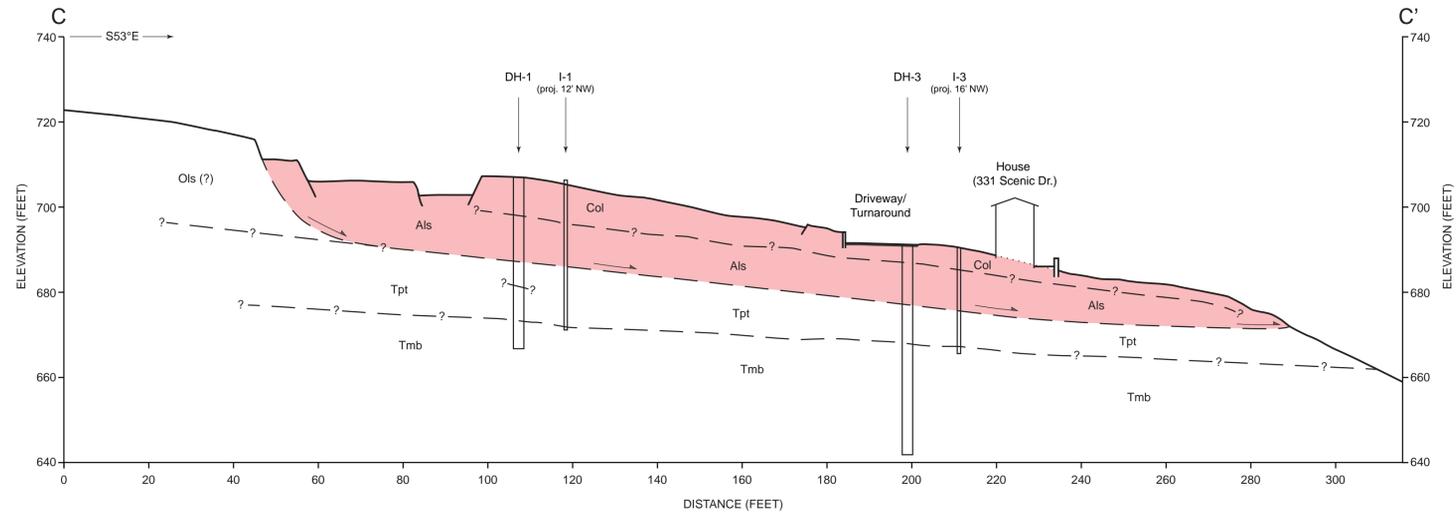
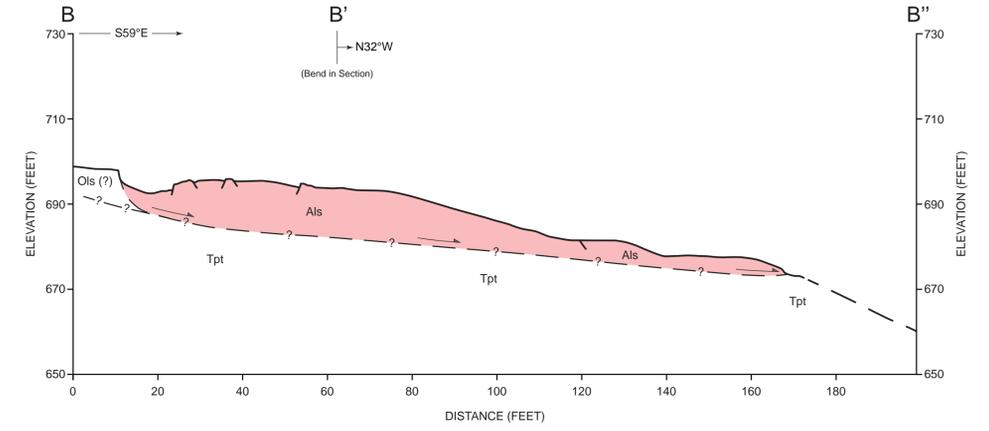
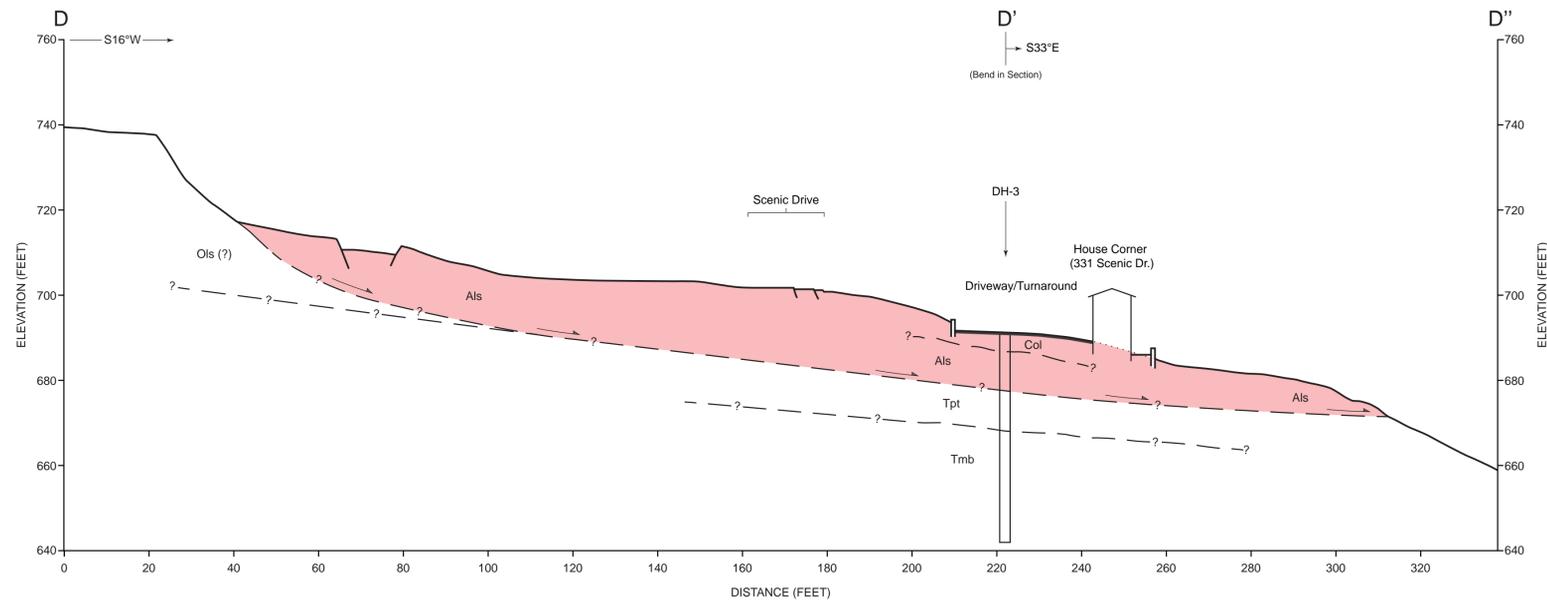
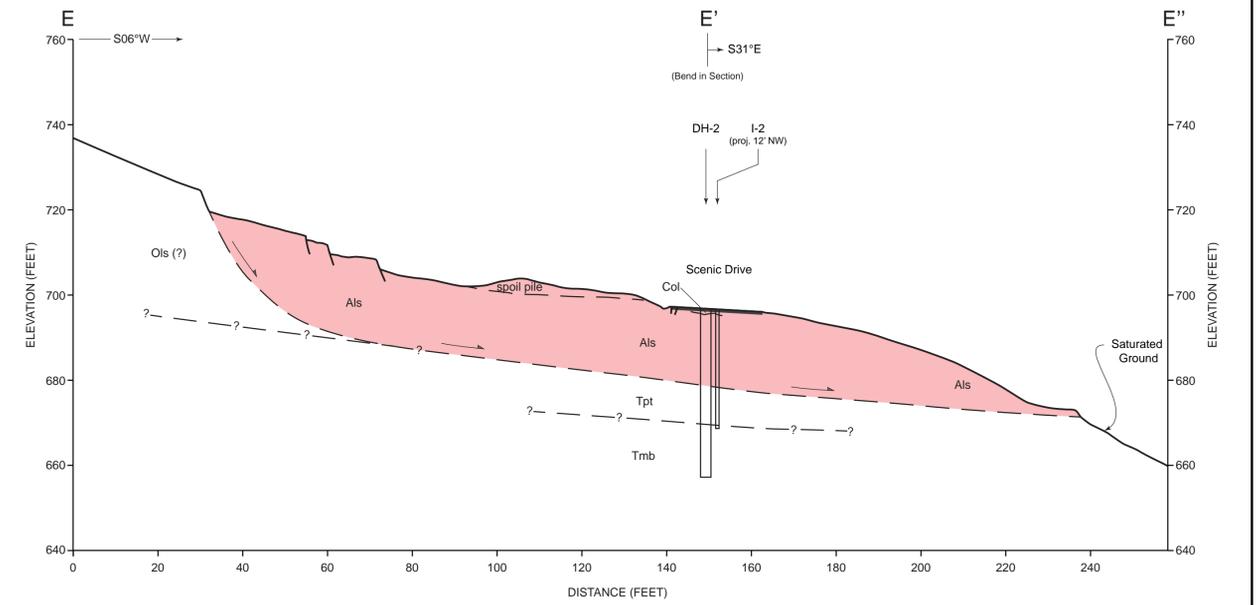
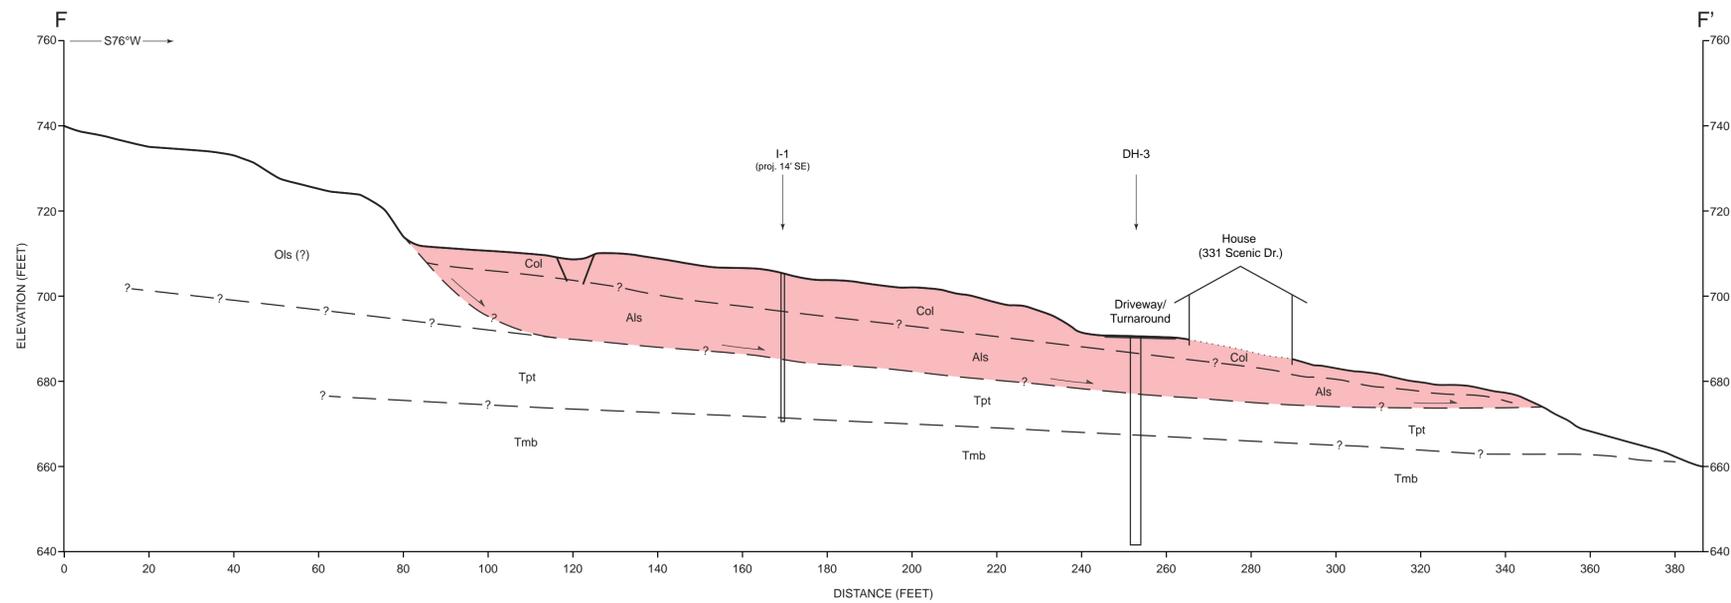
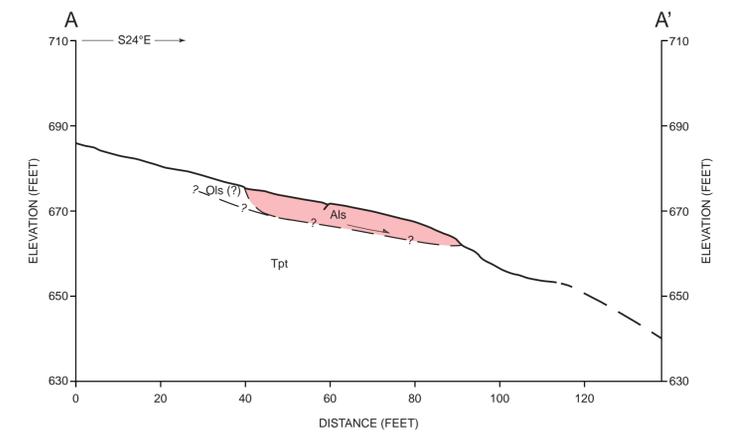
Drafted By: GDG	GEOLOGIC CROSS SECTIONS SCENIC DRIVE SAN MATEO COUNTY, CALIFORNIA	FIGURE
	Date: May 2018		6
	Checked By: JF		PROJECT
	Revision:		PA17.1039.00

affected the area of the landslide (the leak location is approximately along the projection of Geologic Section F-F' through the central portion of the landslide parallel to the dip direction of the landslide plane and bedding);
