Project Name and Location Highlands 2188 Cobble Hill, San Mateo, CA	
---	--

Date and Time of Inspection: Tue, 01/28/2020 11:26 AM	Date Report Written: 1/28/2020 3:56:59 PM
Inspection Type: Weekly

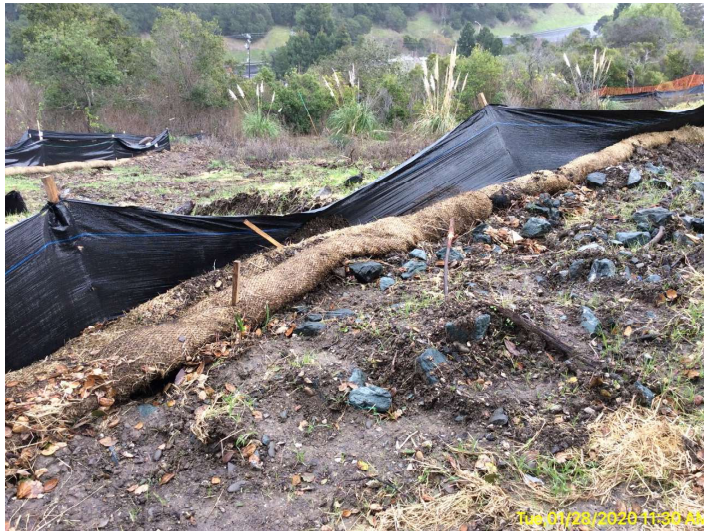
Comments: Silt fence needs repairs.

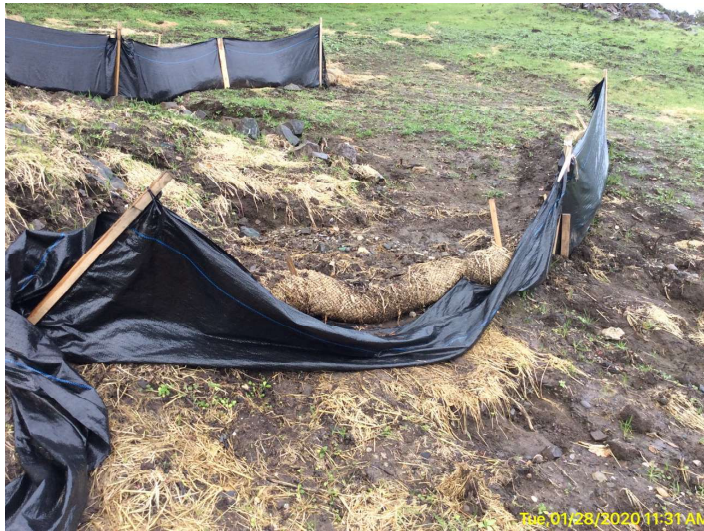
Comments: Silt fence needs repairs.
