**GEOLOGIC AND GEOTECHNICAL INVESTIGATION
SCENIC DRIVE LANDSLIDE**

SAN MATEO COUNTY, CALIFORNIA

**JUNE 13, 2018
PROJECT PA17.1039.00**

**County of San Mateo
Department of Public Works
555 County Center, 5th Floor
Redwood City, CA 94063-1665**

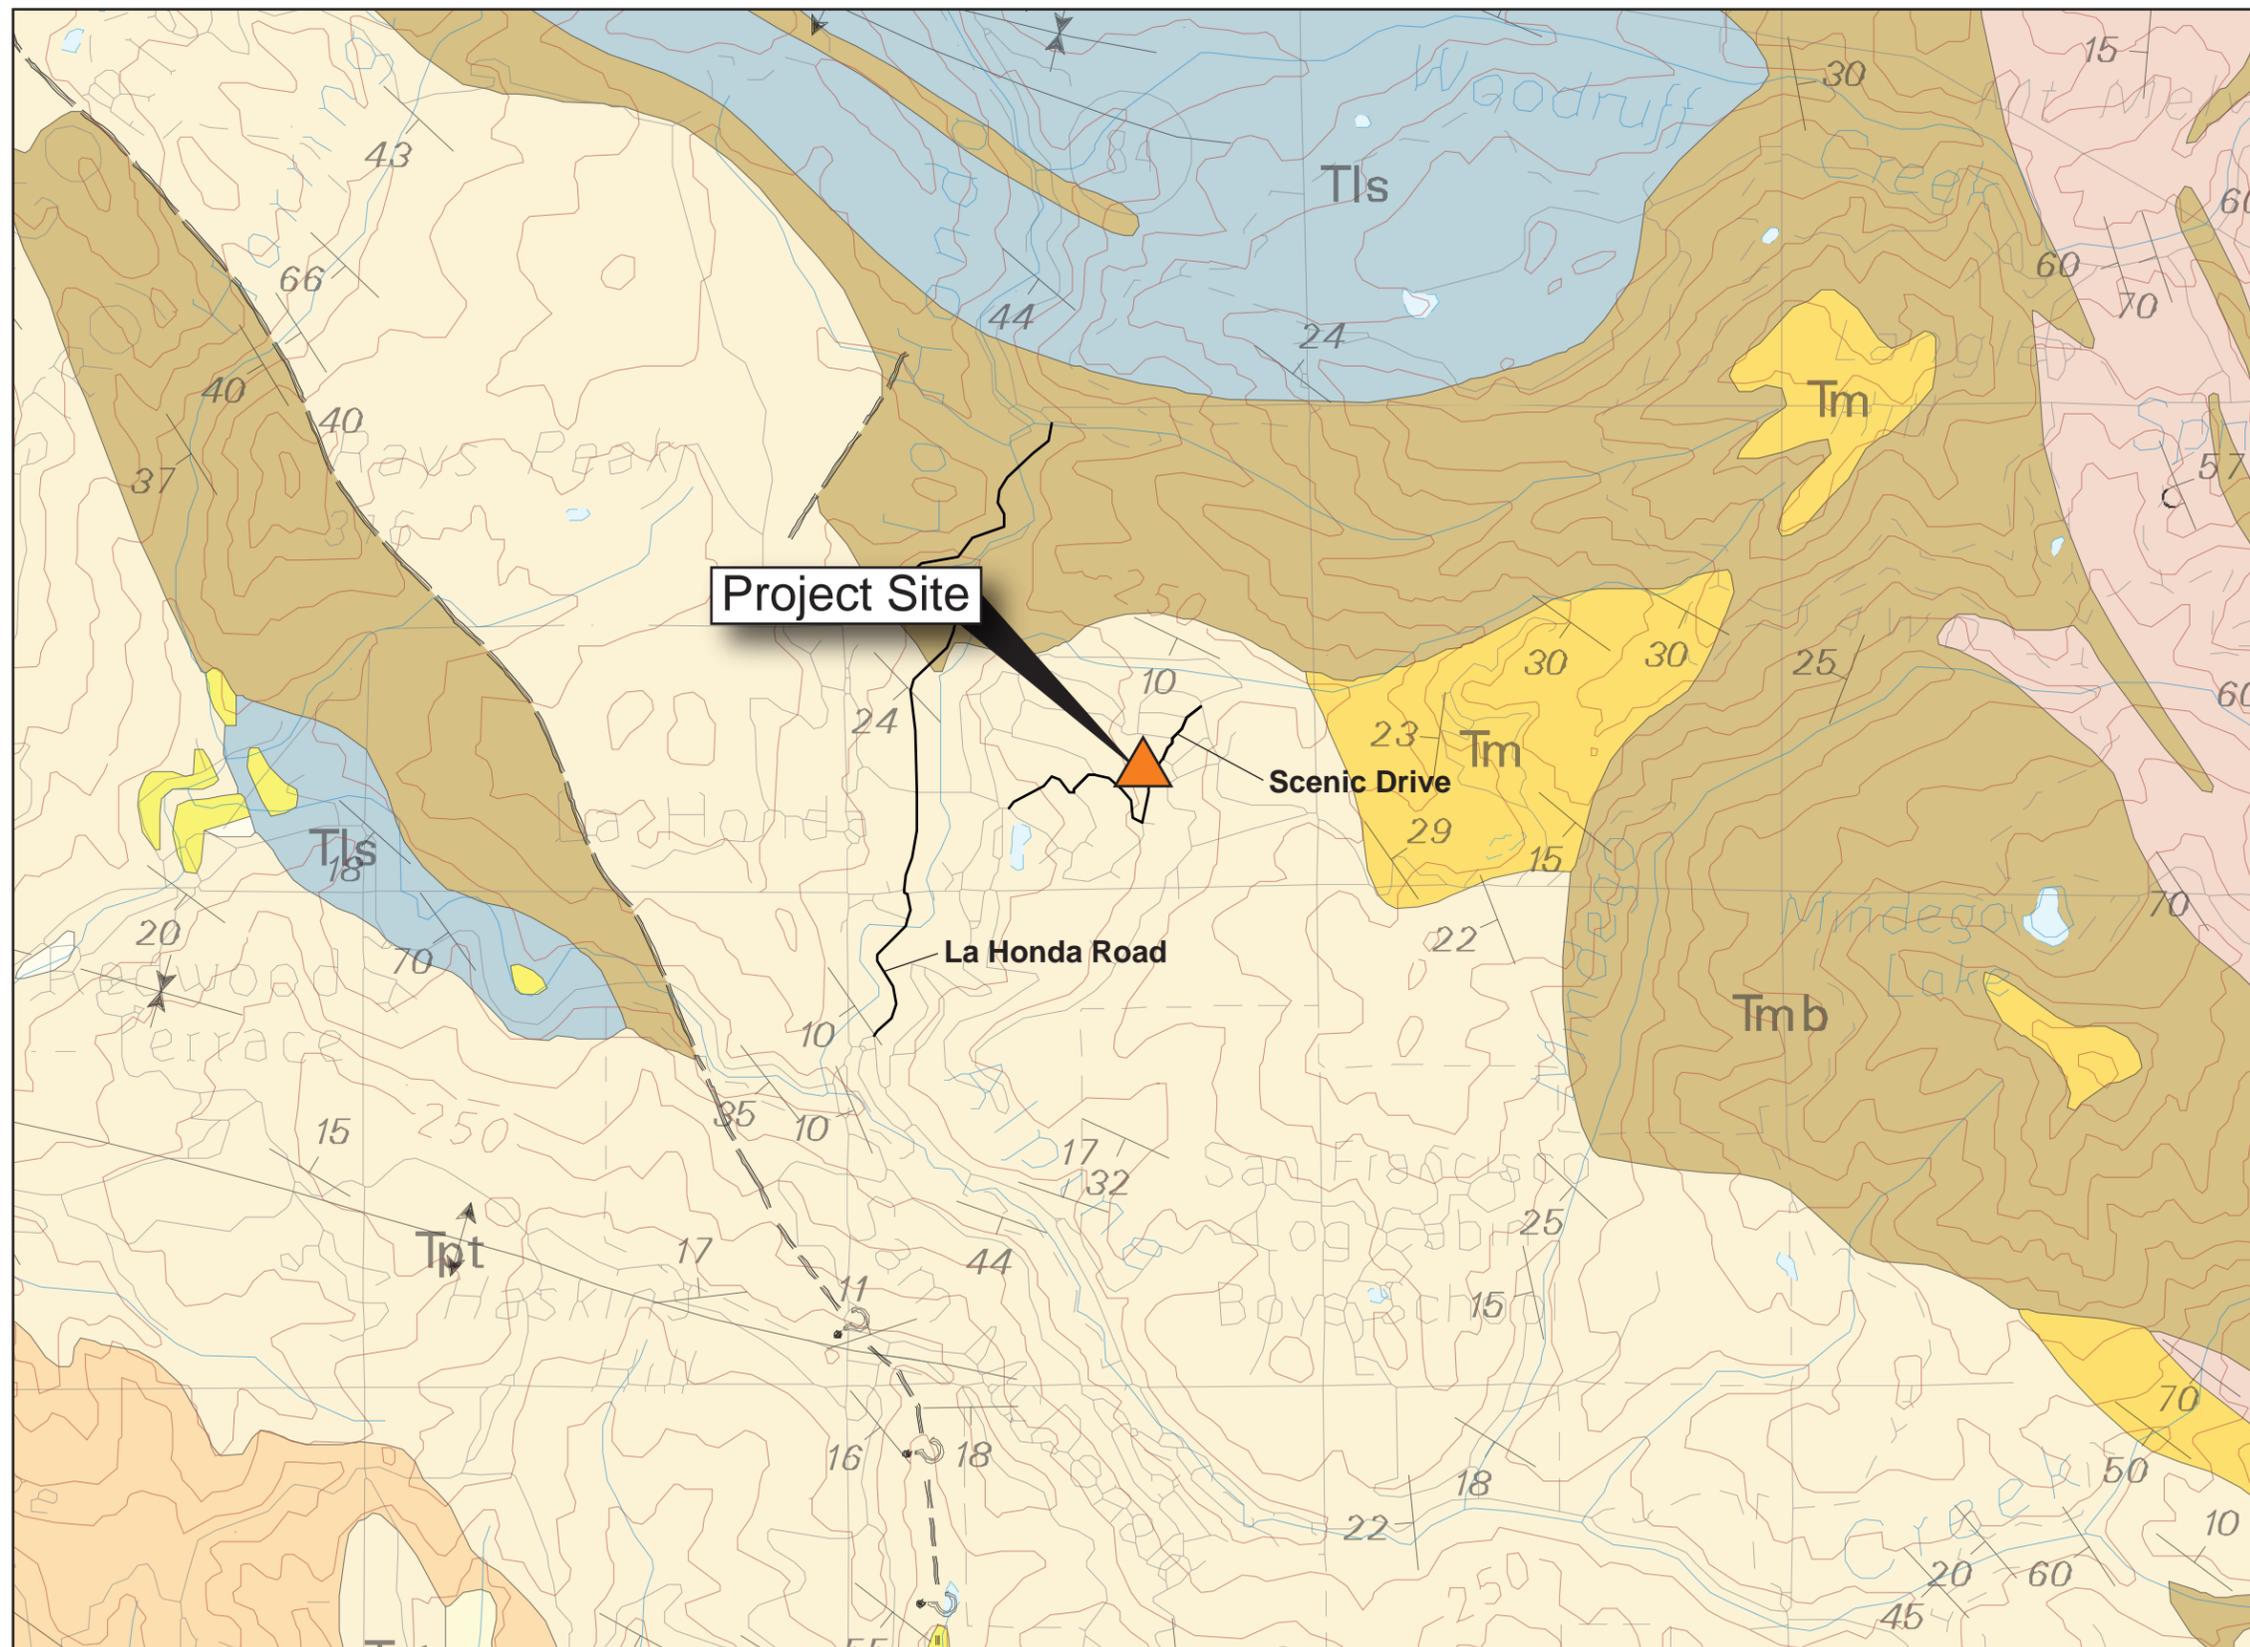
FIGURE
3

project area within a much larger old, deep-seated landslide (Landslide A, Figure 3), it is likely that the older landslide deposits are remnants of a pre-existing landslide and that the geomorphic features such as the scarp and toe have eroded.

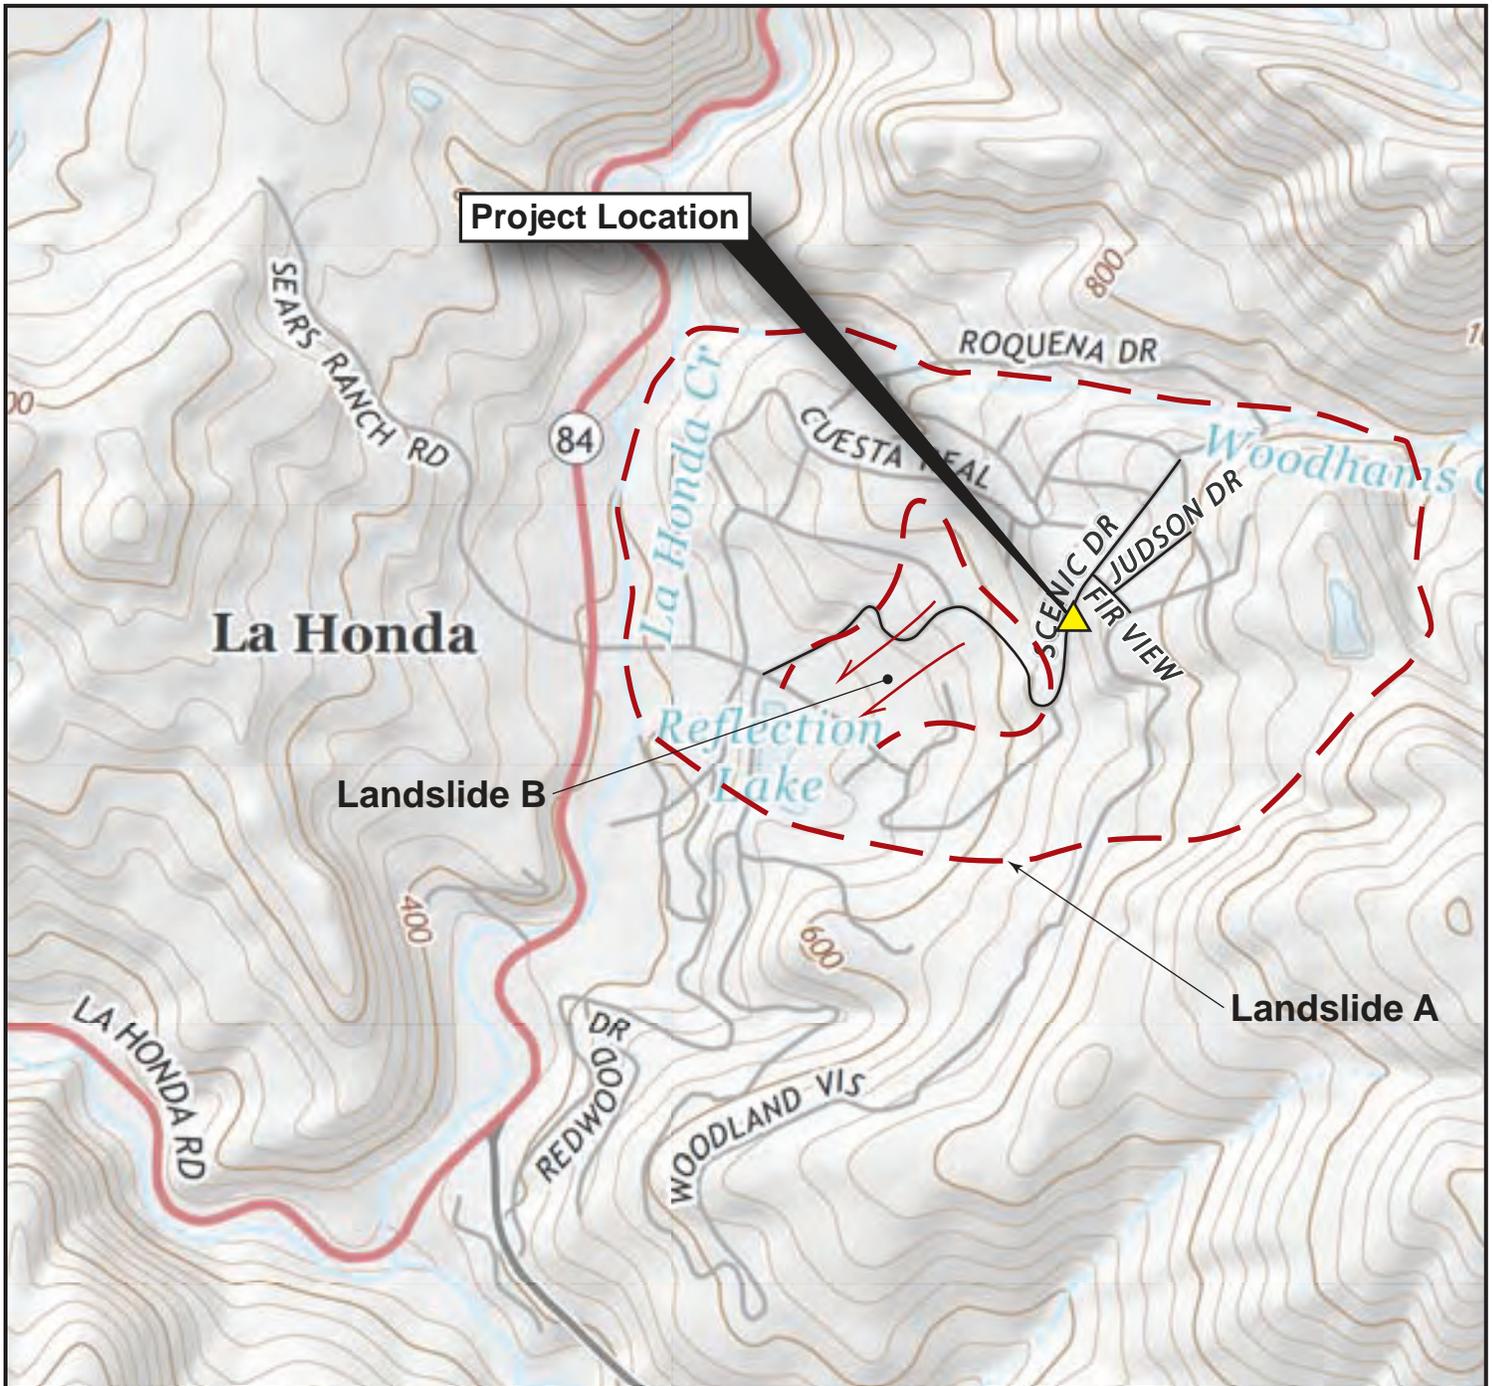
The aerial photographs indicate a slightly better defined topographic low surrounded by irregular concave slopes near the center of the Landslide A slide mass. This topographic low is interpreted to be a relatively younger, old landslide and is identified as "Landslide B" in Figure 3. The 1973 aerial photographs also indicate a subtle concave depression near the project location that suggests possible prior movement in this area (probably hundreds of years ago).

Probable landslide, arrows indicate approximate direction of movement.
