Addendum No. 3
Serenity House

SERENITY HOUSE
3701 Hacienda Street
San Mateo, CA
Project No. PC023

**SUMMARY REPORT:
HAZARDOUS MATERIALS SURVEY
3701 HACIENDA STREET
SAN MATEO, CA 94403**

**SUMMARY REPORT OF ENVIRONMENTAL QUALITY
ASSURANCE SERVICES
SERENITY HOUSE RENOVATIONS
3701 HACIENDA STREET
SAN MATEO, CA 94403**

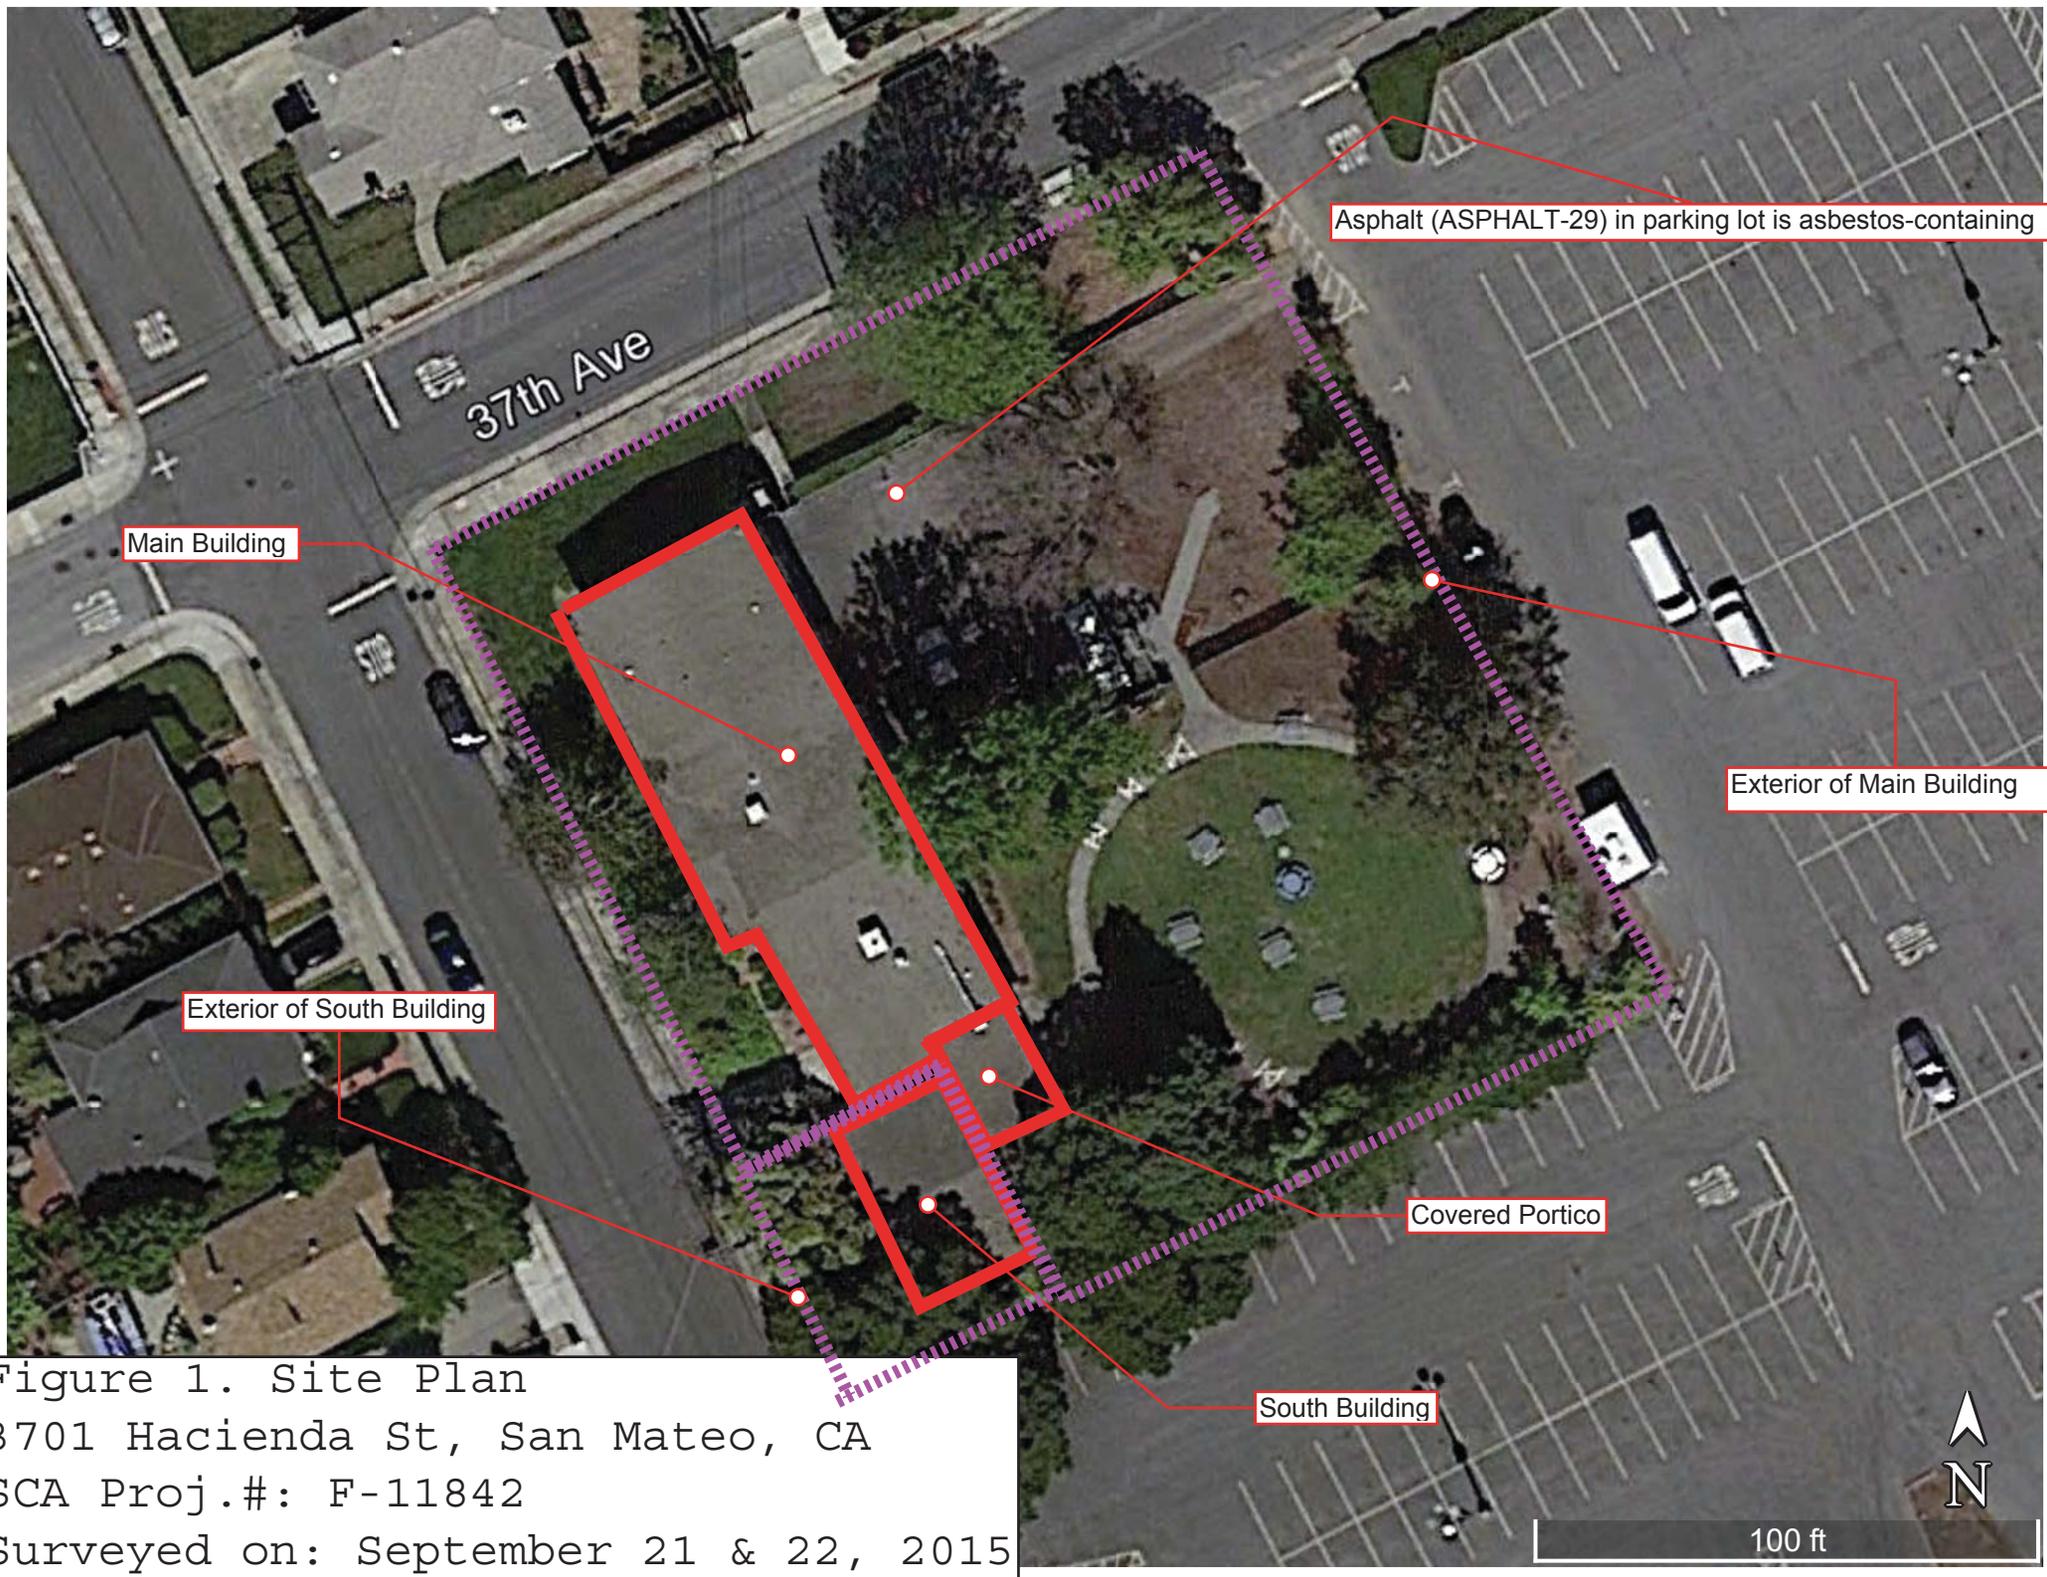
Figure 1. Site Plan
3701 Hacienda St, San Mateo, CA
SCA Proj.#: F-11842
Surveyed on: September 21 & 22, 2015

Plate 1: Site Map

The project includes 2 structures defined as follows and depicted on the Site Map in Plate 1 (attached) as well as various parking, paved and unpaved areas, and a covered portico:
