MANHOLE INSPECTION
TECHNICAL MEMORANDUM

Subject: Sanitary Sewer and Water System Evaluation Study
Manhole Inspection Memorandum of Field Work

**GRAPHICAL FLOW SUMMARY
GRAPHICAL PLOTS OF MINIMUM, DAILY, AND PEAK FLOW RATES**

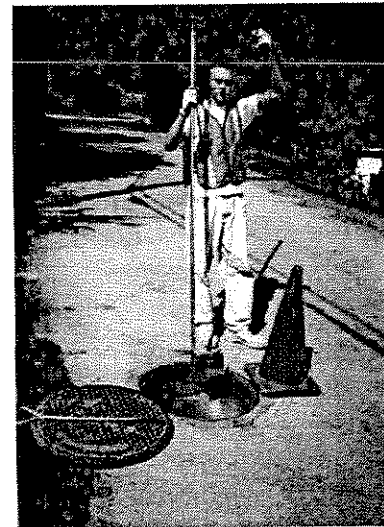
Figure 1

In order to collect additional data on each manhole location a “Camera on a Stick” (Figure 1) was lowered into the manhole and a photograph of each pipe entering and leaving the manhole was taken. Where infiltration/inflow or other manholes conditions warranted a photograph was also taken from the “Camera on a Stick”.

The view in the pipeline using the “Camera on a Stick” is dependent on the flow, debris, and channel benching in the manhole. Where the camera can be placed in the channel with a clear view of the pipeline the photograph typically shows approximately 20 feet of the sewer away from the manhole for an 8-inch diameter sewer. Larger sewer diameters typically show a longer distance and smaller sewer diameters show a shorter distance.
